DOHERTY BUILD

Roof Condition Survey Report

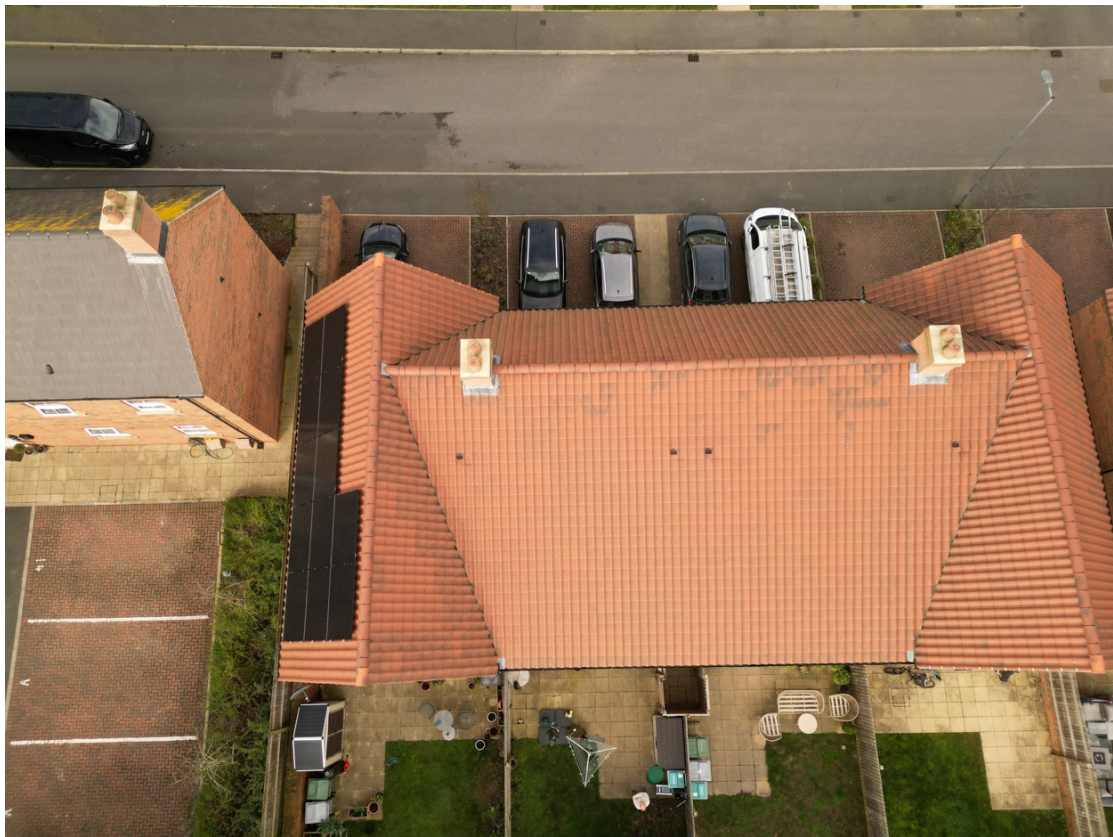
Fig. 1 — Top-down aerial view of the full roof area. Clay interlocking pantiles in generally sound condition. Two chimney stacks visible with lead flashings intact. Roof vent tiles visible on the main roof slope. Solar PV panels on the adjacent property (left).

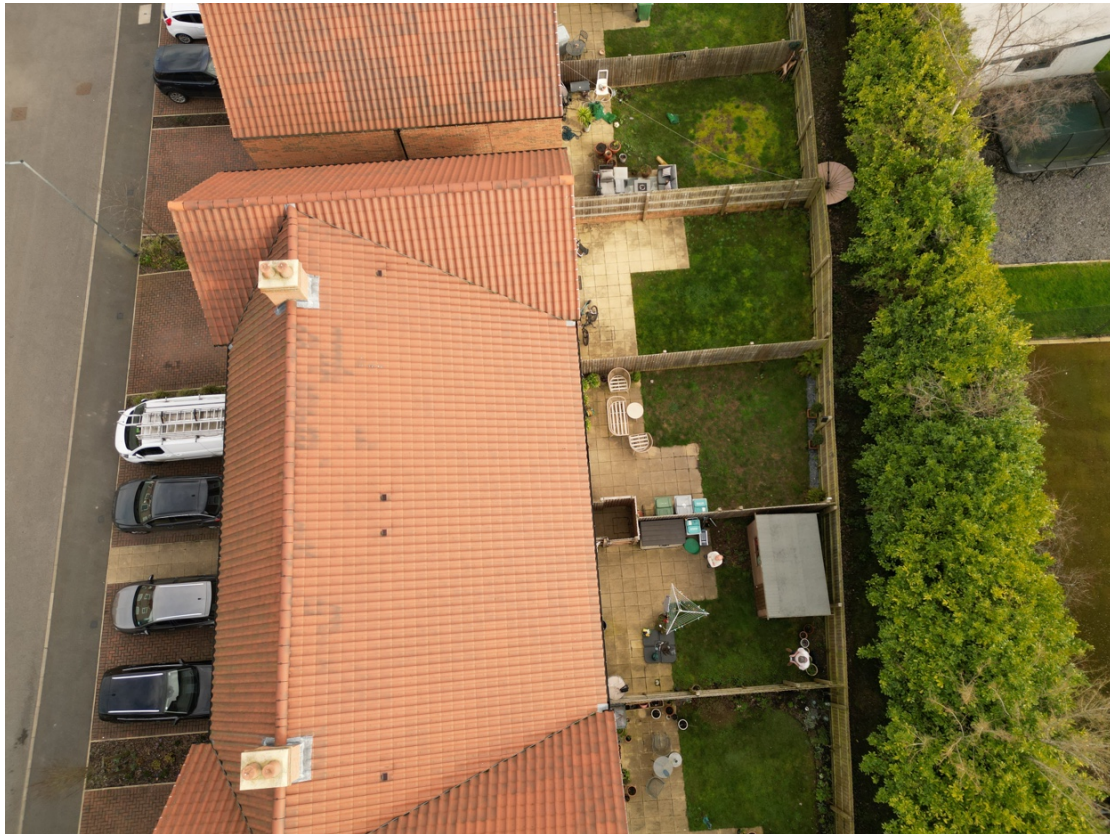
Fig. 2 — Top-down aerial view from alternative angle showing the full roof and surrounding context. No visible signs of widespread tile displacement, delamination, or structural movement. Ridge line and hip junctions appear true and correctly aligned.

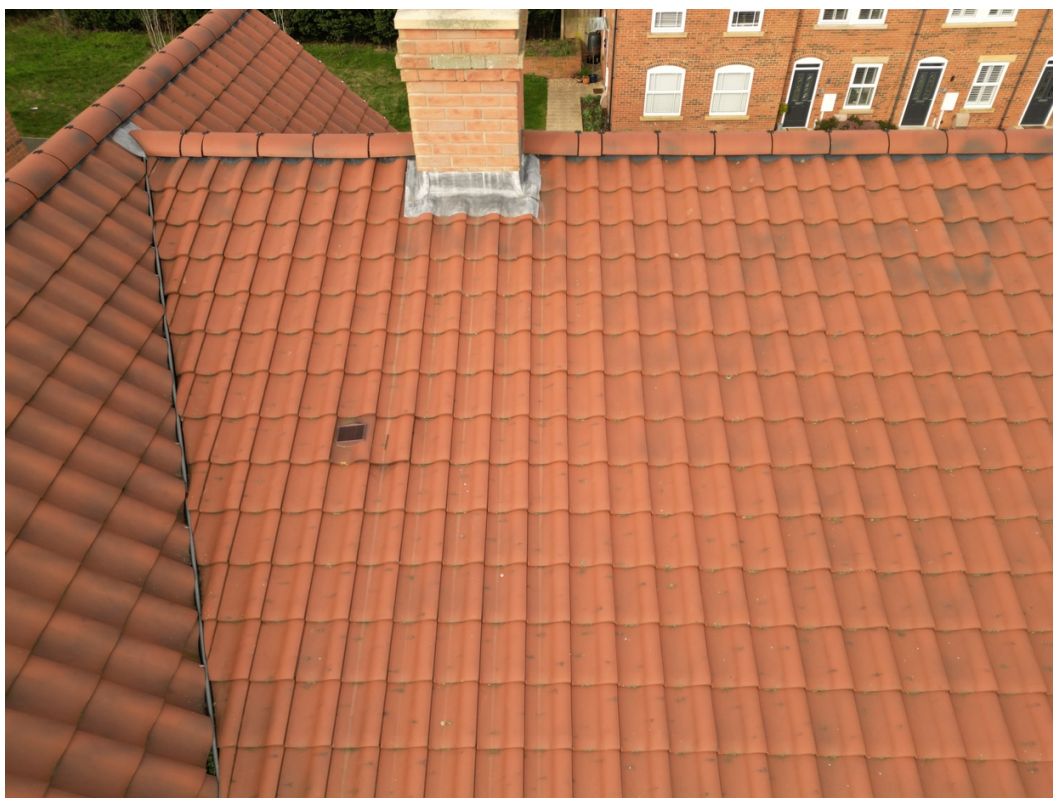
Fig. 3 — Oblique aerial view of the main roof slope showing the chimney stack and roof vent tile (visible below and to the left of the chimney). The vent tile sits within the main field of interlocking tiles on the principal roof slope.

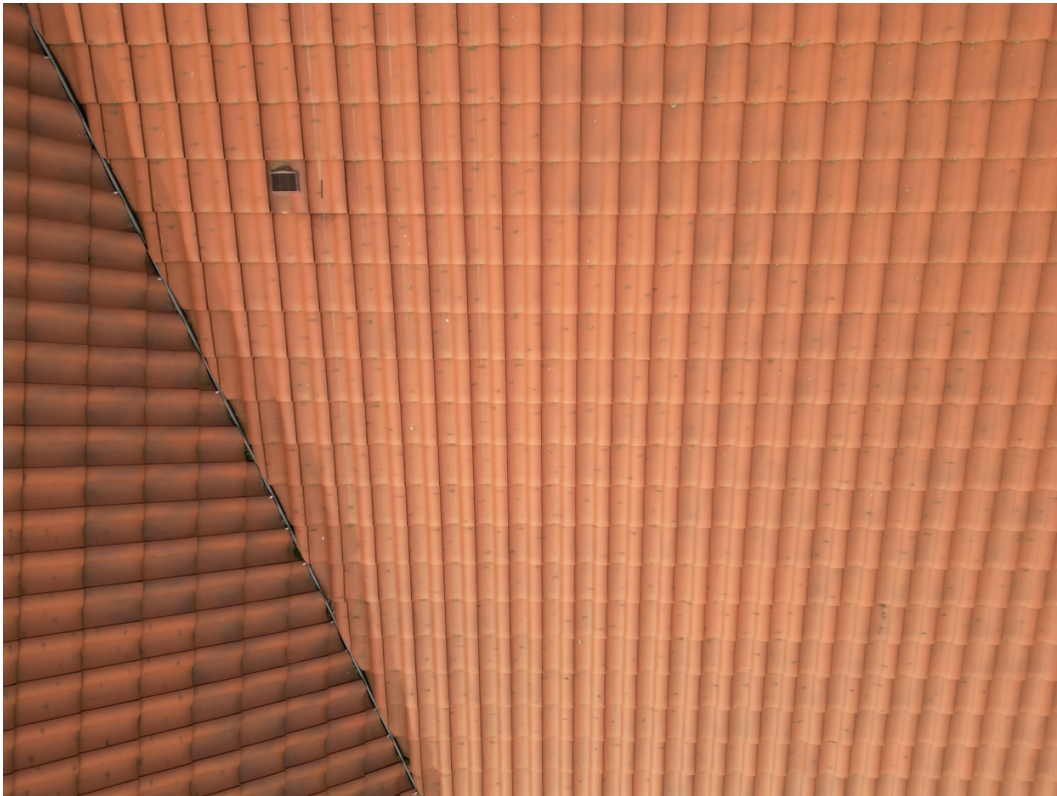
Fig. 4 — Close-up aerial view showing the interlocking tile profile and vent tile position. The tile trough (low channel between profiles) can be clearly seen running directly into the vent location, confirming the water channelling effect described above.

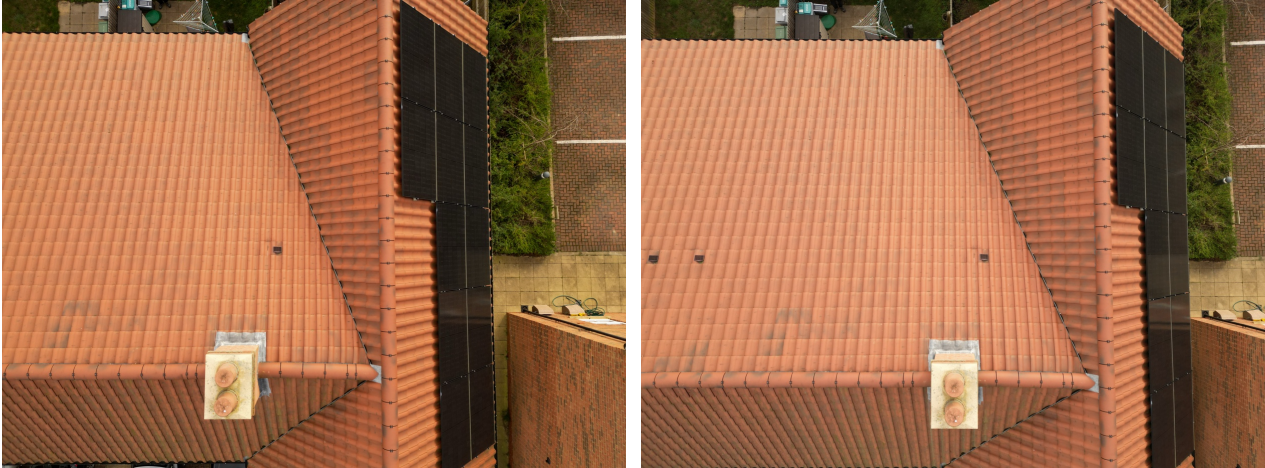
Fig. 5 & 6 — Chimney stack detail showing twin clay pots, lead flashing apron, and stepped/back-gutter flashings. Solar PV panels visible on the adjacent building's roof slope. The chimney flashings appear to be in serviceable condition with no obvious lifting, cracking, or separation at the time of survey.
